Welsh Government Newtown Traffic Issues Summary Report

11-8260

Issue 2 | 25 April 2012

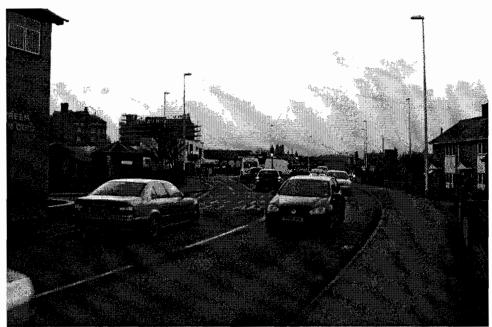
Photograph 3.1: Showing the poor straight through alignment from Pool Road.

Photograph 3.1 highlights the poor straight through alignment from Pool Road (East). Photograph 3.2 demonstrates the limited right turn queuing length, and the

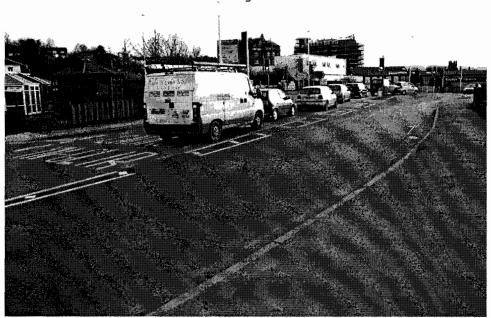
Photograph 3.2: Showing the right turn lane and the 'keep clear' markings over Sheaf Street.

interaction with the 'keep clear' markings. Photograph 3.3 shows the impact of the right turn queue affecting the straight through movement.

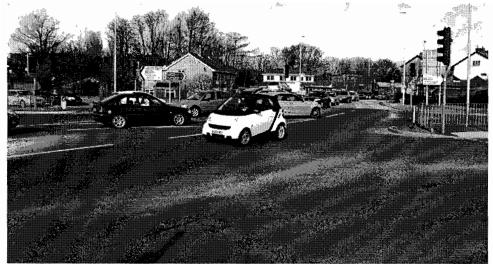
Photograph 3.3: Showing vehicles waiting to right turn in the middle of the junction, whilst straight through traffic is restricted by the right turn queue.

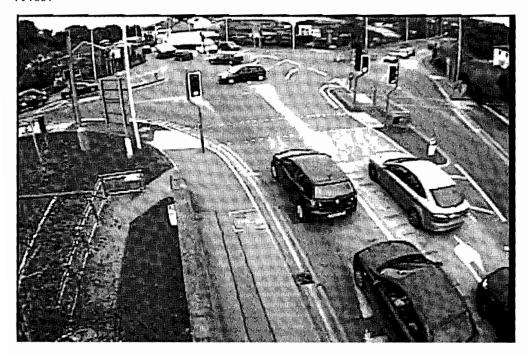
Photo 3.4: Video footage used to help calibrate the microsimulation model

The model has been developed using VISSIM 5.30 software, and calibrated to local driver behaviour from on site observations and using video footage of the traffic signal controlled junction. A still from the video is shown in Photo 3.4.
